## Appendix K – Listed Buildings in Attleborough

**Attleborough Transport Study**  
PARAMICS MODELS - AM CALIBRATION RESULTS

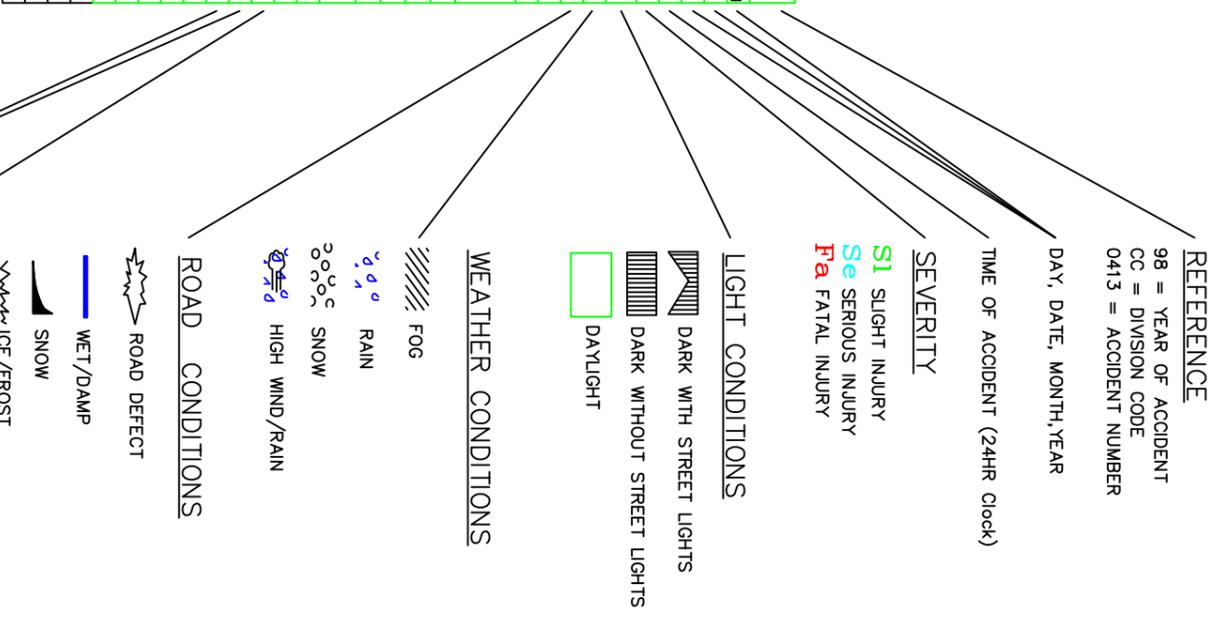
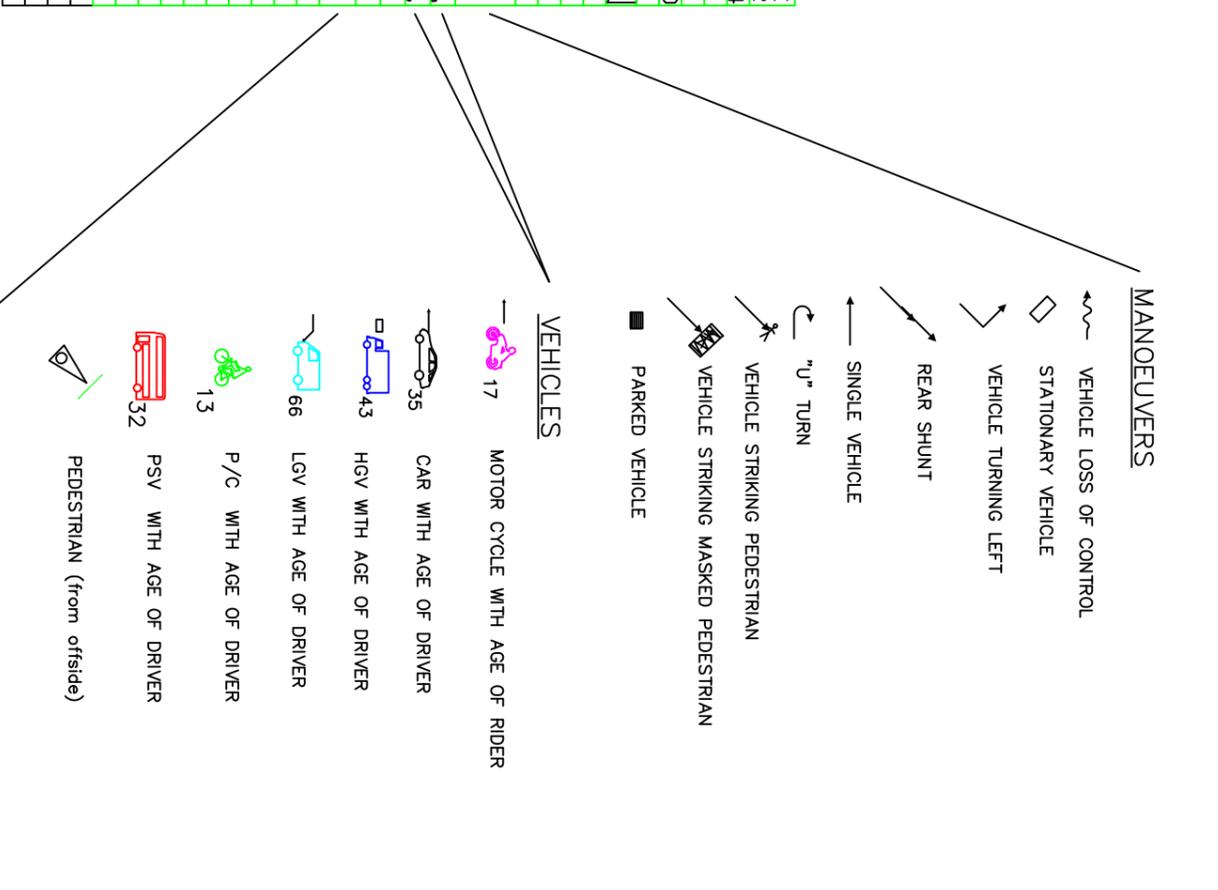
Reference Number	Date / Day / Month / Year / Time	Severity	Dark / Lit	Weather Conditions	Road Surface	Special Conditions	Carriageway Hazards	Vehicle Manoeuvres	Casualty /age	Breath Test	Contributory Factor 1/2	Contributory Factor 3/4	School No./Ref.
99CC 0151	Wed 19 Feb 92 0900	Se	Se					Vehicle 1: 5 t Vehicle 2: 6 t Vehicle 3: 7 c Vehicle 4: 8			24	24	321
00CC 0326	Thu 16 Apr 92 1405	S1	S1									220	220
98CC 0413	Wed 20 May 99 1901	S1	S1								27	27	331

Reference Number	Date / Day / Month / Year / Time	Severity	Dark / Lit	Weather Conditions	Road Surface	Special Conditions	Carriageway Hazards	Vehicle Manoeuvres	Casualty /age	Breath Test	Contributory Factor 1/2	Contributory Factor 3/4	School No./Ref.
96EE 0071	Tue 27 Feb 96 2130	S1	S1					Vehicle 1: 5 t Vehicle 2: 6 t Vehicle 3: 7 c Vehicle 4: 8			36	36	0621
96EE 0097	Fri 15 Mar 96 1035	Se	Se									321	321
96EE 0152	Wed 24 Apr 96 0800	S1	S1								81	81	321

98 = YEAR OF ACCIDENT  
CC = DIVISION CODE  
0413 = ACCIDENT NUMBER
